This is the Year 2 Summer evaluation for the UT Hiwassee River stream relocation. A few of the crossvanes continue to have water piping under them and water is still piping under ground below the driveway culvert due to the blasting that took place during construction to relocate the stream. Some erosion exist at Sta. 15+00 as noted below. A permit modification was completed to relocate an additional 135 feet of stream at Site 11. Photo Point numbers 10 and 11 up and down stream, respectively show this additional 135 feet. This section of stream relocation is mainly bedrock. NCDOT will continue to monitor this stream relocation.

# UT Hiwassee River

Year 2 Summer – August 2009

UT Hiwassee River  
R-977A  
Cherokee County

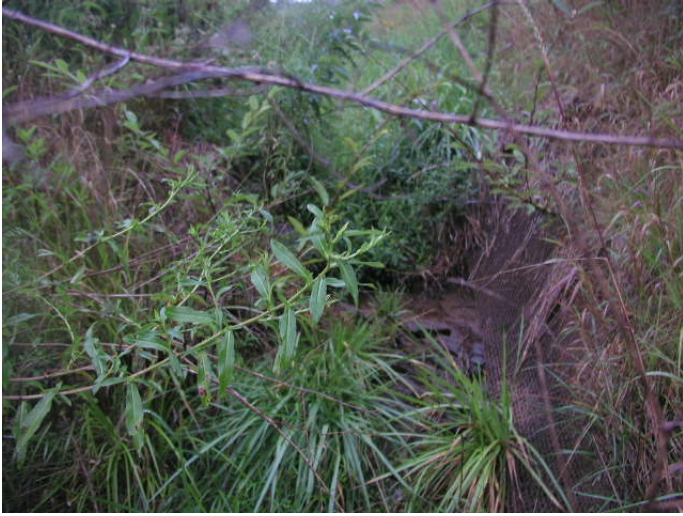
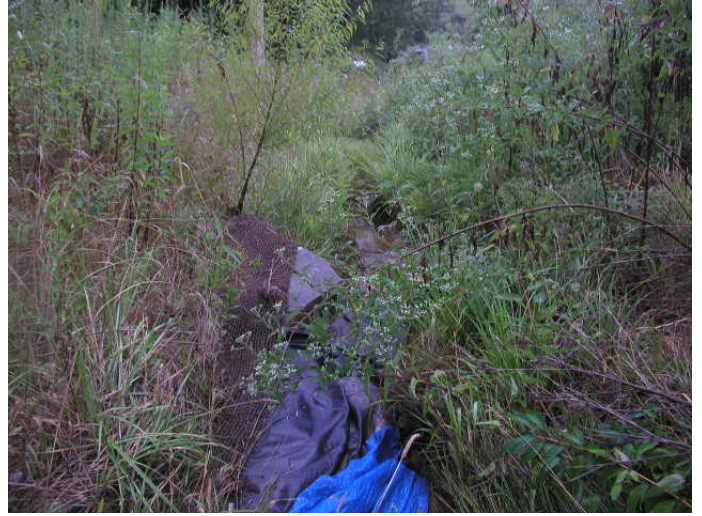
Date Inspected 8/12/09	Station 13+20 PP#7 Upstream and Downstream Photo	Station 13+00 Additional Photo	Station 13+20 to 13+80 Between PP#5 and PP#7	Station 15+00 Additional Photo	Station Number
Structure Type	Crossvane	Crossvane		Crossvane	
Is water piping through or around structure?	Water piping under crossvane due to blasting that took place to relocate stream		Water bypassing stream bed underground where blasting took place		
Head cut or down cut present?					
Bank or scour erosion present?				Erosion on right bank at the right arm of a crossvane	
Other problems noted?		Header rock has been displaced but not affecting stream stability due to bed rock in channel

Photo Point #7 (Upstream)

Photo Point #7 (Downstream)

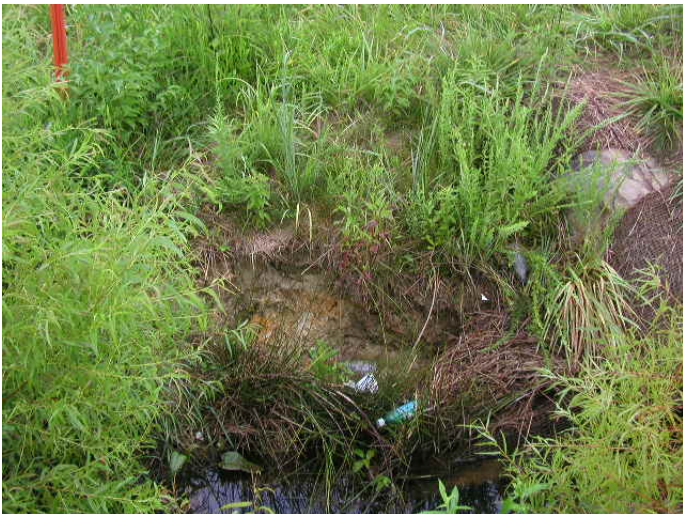
Erosion @ Sta. 15+00

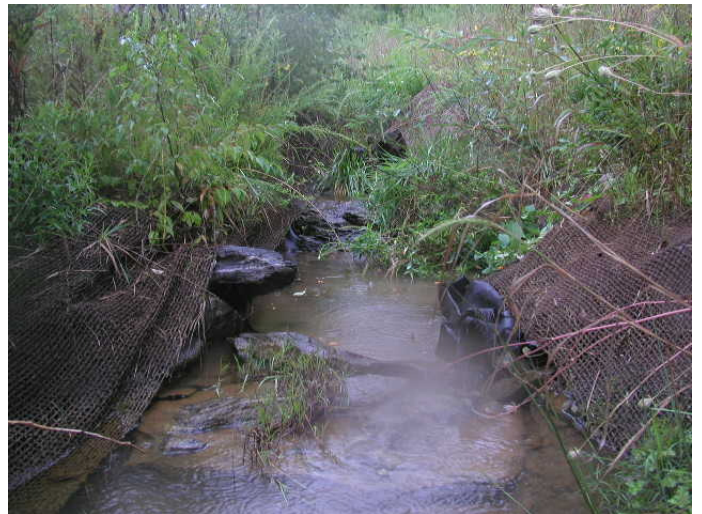
Crossvane w/ displaced header rock @ Sta. 13+00
